CITY OF SPRINGFIELD SPRINGFIELD, ILLINOIS

SEWER REHABILITATION, SRF

ISSUE DATE 1/12/2026
CITY CONTRACT NO. - PW26-04-12
IEPA PROJECT NO. - L17-7124

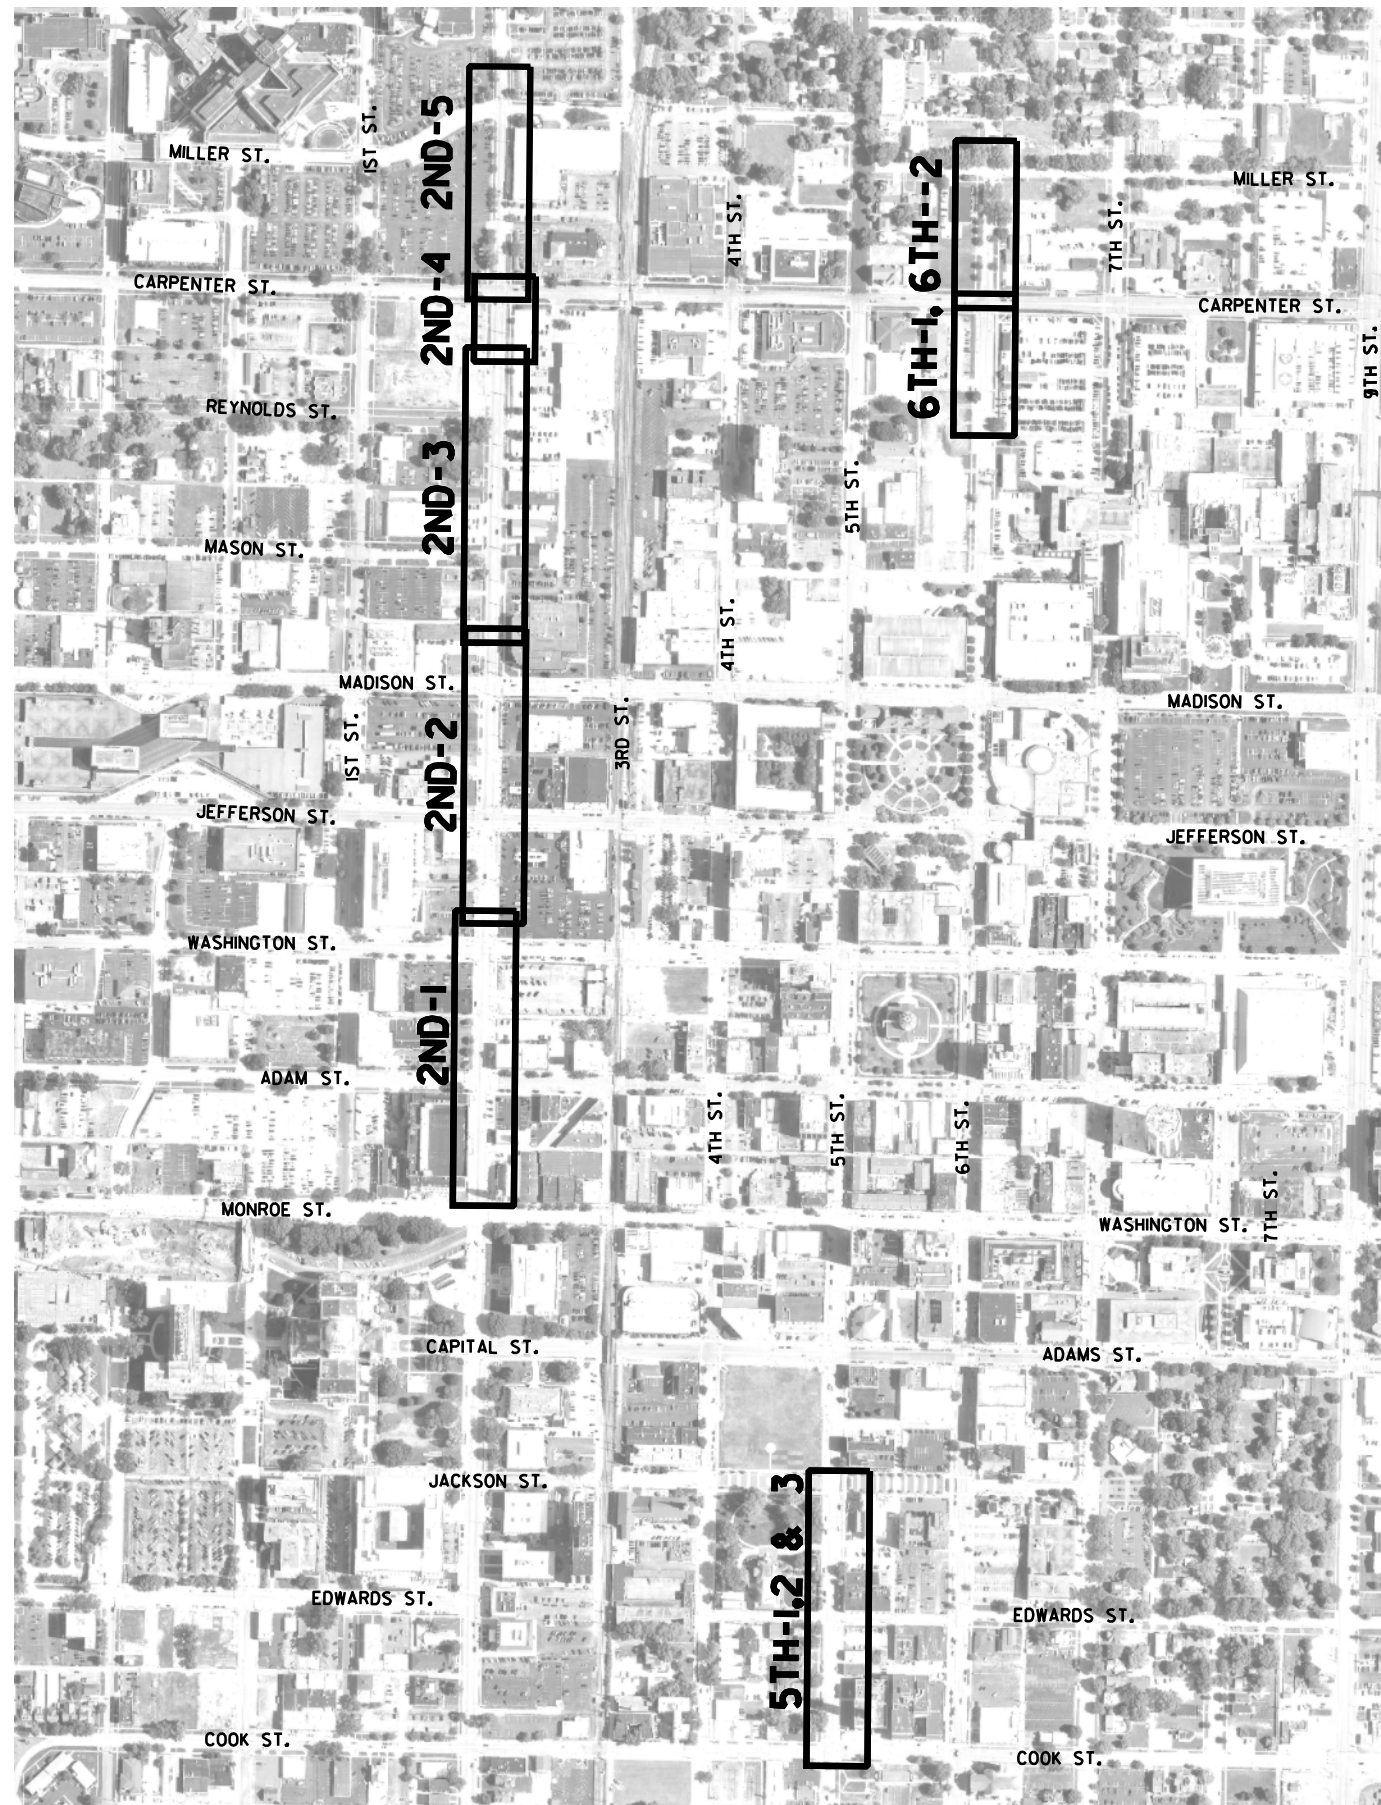
2ND, 5TH & 6TH ST. COMBINED SEWER REHABILITATION
KEY MAP

2ND, 5TH & 6TH COMBINED SEWER REHABILITATION KEY TABLE		
PIPE SEGEMENT	ID	SHEET NO.
2ND STREET		
1434AB057-1434AB055	2ND-1	10
1427EF025-1427EF109	2ND-1	10
1427EF073-1427EF025	2ND-2	11
1427EF111-1427EF073	2ND-3	11
1427EF074-1427EF111	2ND-3	12
1427EF102-1427EF074	2ND-3	12
1427EF101-1427EF100	2ND-4	13
1427EF100-1427EF099	2ND-5	14
5TH STREET		
1434AB026-1434AB029	5TH-1	15
1434AB029-1434AB094T	5TH-1	15
1434AB027-1434AB030	5TH-2	16
1434AB030-1434AB096T	5TH-2	16
1434AB028-1434AB031	5TH-3	17
1434AB031-1434AB097T	5TH-3	17
6TH STREET		
1427EF080-1427EF087	6TH-1	18
1427EF087-1427EF092	6TH-2	19

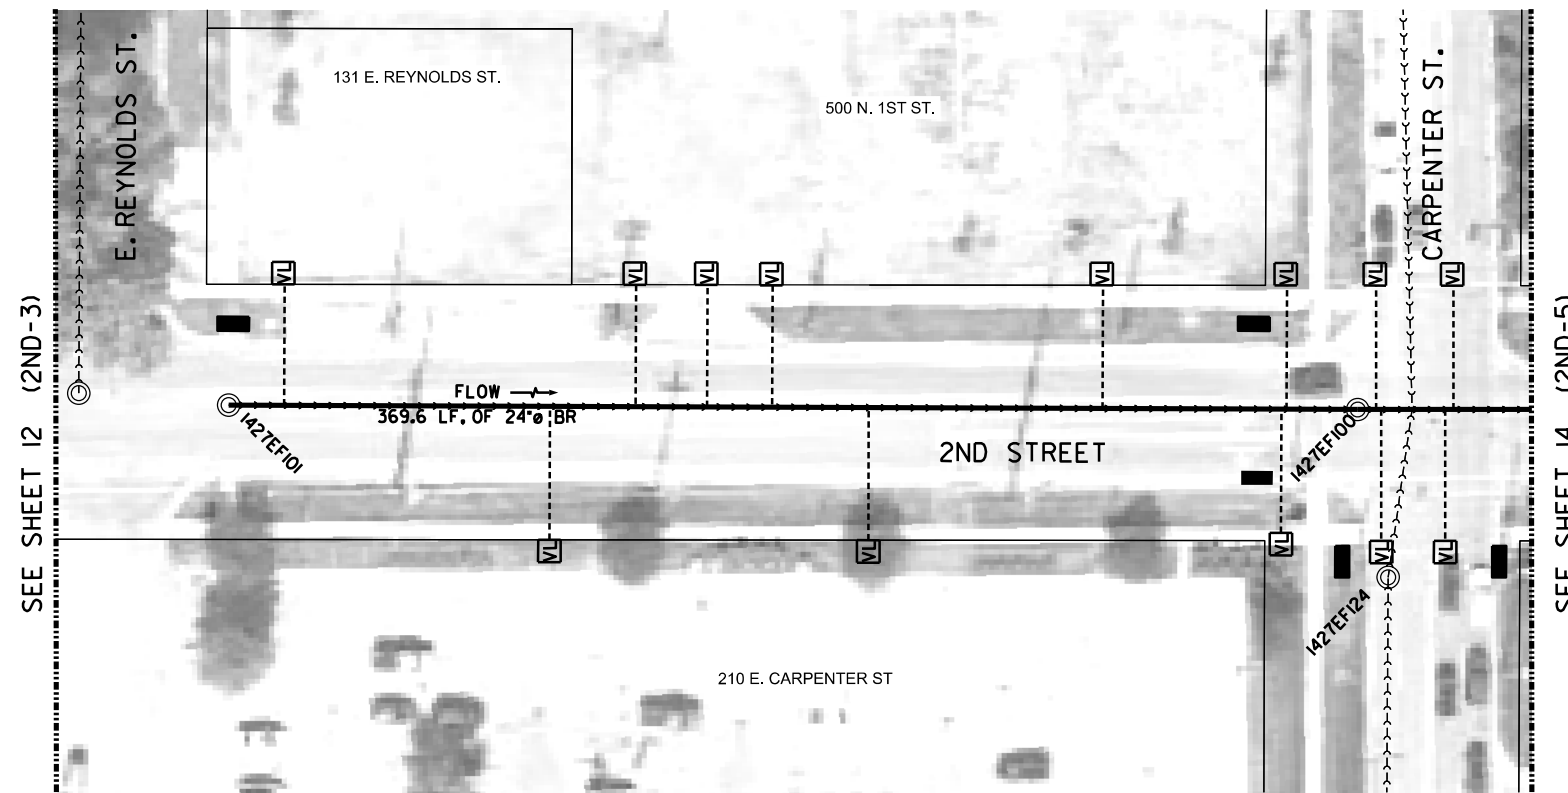
0.0	MWL	15%					
	0.0	S01	MML			MISSING MORTAR - HEAVY AT TIMES AND NOT SURE HOW BRICKS ARE STAYING IN PLACE.		
	0.0	S02	DSZ	15%	5	7	REMOVE SILT AND DEBRIS

21.7	HSV				4	HOLE ADJACENT TO TAP	
	22.3	TB	12"			3	TAP BREAK IN - VCP	
	23.9	TBD	12"			9	TAP BREAK IN - VCP - DEFECTIVE - UPSTREAM PIPE SECTION HAS DROPPED AND NO CONTINUOUS CONNECTION IN THE PIPE EXISTS.

169.7	MB				9	MISSING BRICK	
	181.2	DAE	5%			12	3	REMOVE ENCRUSTATIONS
	183.6	TB	8"			3	TAP BREAK IN - VCP - DEBRIS IN LATERAL (~75%)	
	194.6	S03	DSZ	15%	5	7	REMOVE SILT AND DEBRIS

234.0	MB				9	MISSING BRICKS	
	253.3	TR	6"			4	TAP BREAK IN - VCP	
	319.2	MWL	35%					
	336.6	TBA	6"			3	TAP BREAK IN - VCP - ACTIVE	
	369.6	F01	MML				MISSING MORTAR - HEAVY AT TIMES AND NOT SURE HOW BRICKS ARE STAYING IN PLACE.

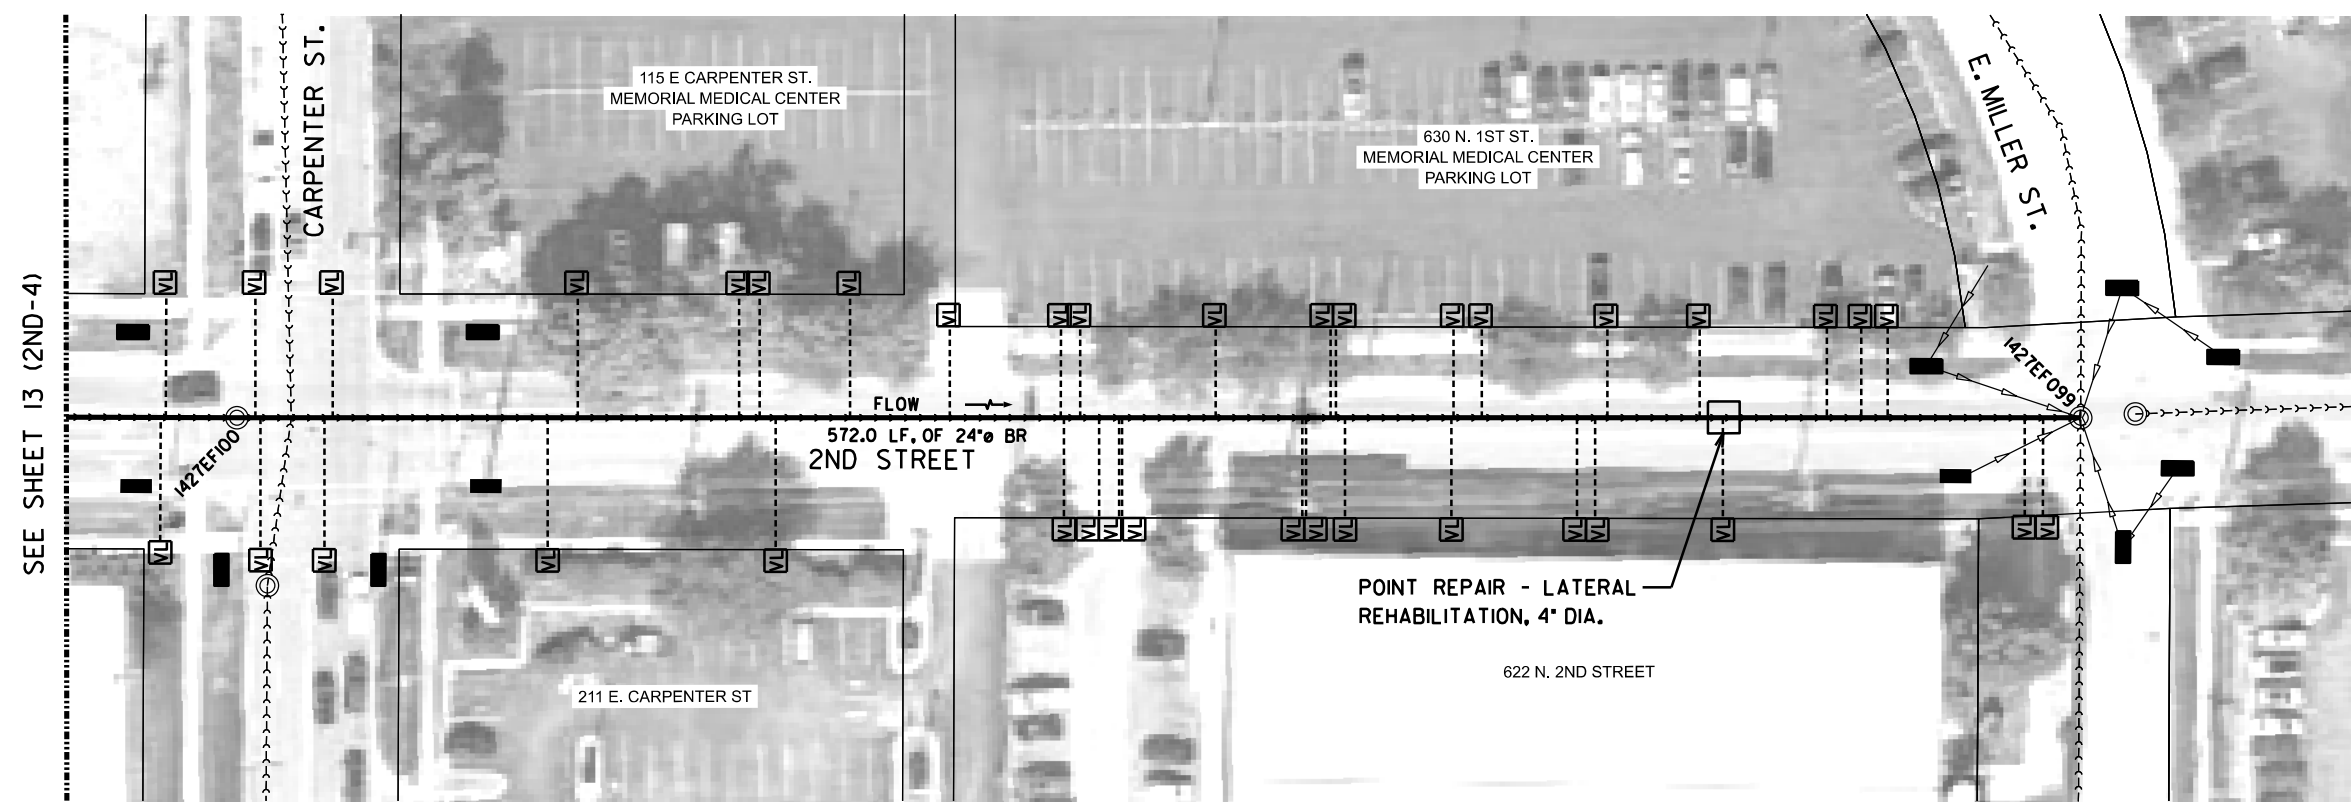
PIPE SEGMENT	U.S. MANHOLE	D.S. MANHOLE	STREET OR CLOSEST STREET	SECOND STREET		
1427EF100	1427EF100	1427EF099				
PIPE DIAMETER	24"					
PIPE MATERIAL	BR					
NUMBER OF TAPS TO REINSTATE	36					
DISTANCE (FT)	DESCRIPTOR	LATERAL SIZE/PERCENT FULL	CIRCUMFERENTIAL LOCATION AT/FROM M	TO	REMARKS	
START - 1427EF100

0.0	AMH					
0.0	MWL	15%				
0.0	S01	MML			MISSING MORTAR	
2.0	DSZ	15%			REMOVE SILT AND DEBRIS	
5.4	HVV		8	9	HOLE - INFILTRATION/EXFILTRATION	
5.8	TBI	15"	9		TAP BREAK IN - VCP - INTRUDING 4" - ACTIVE - TRIM FLUSH TO MAIN

465.8	TB	4"	1		TAP BREAK IN - VCP - ANGLE OF TAP ENTERING MAIN WILL LOOK SMALLER OPENING AFTER LINING	
POINT REPAIR	465.8	MGO	4"	1	POINT REPAIR - LATERAL REHABILITATION, 4" DIA. REMOVE AND REPLACE LATERAL CONNECTION (VERIFY DIA. IN FIELD)

556.1	F01	MML			MISSING MORTAR	
556.1	MMC				BR TO PVC	
560.5	TB	6"	2		TAP BREAK IN - PVC	
566.2	TF	8"	6		TAP FACTORY - PVC - OUTSIDE DROP CONNECTION TO MANHOLE	
END - 1427EF099	572.0	AMH			MANHOLE 1427EF099

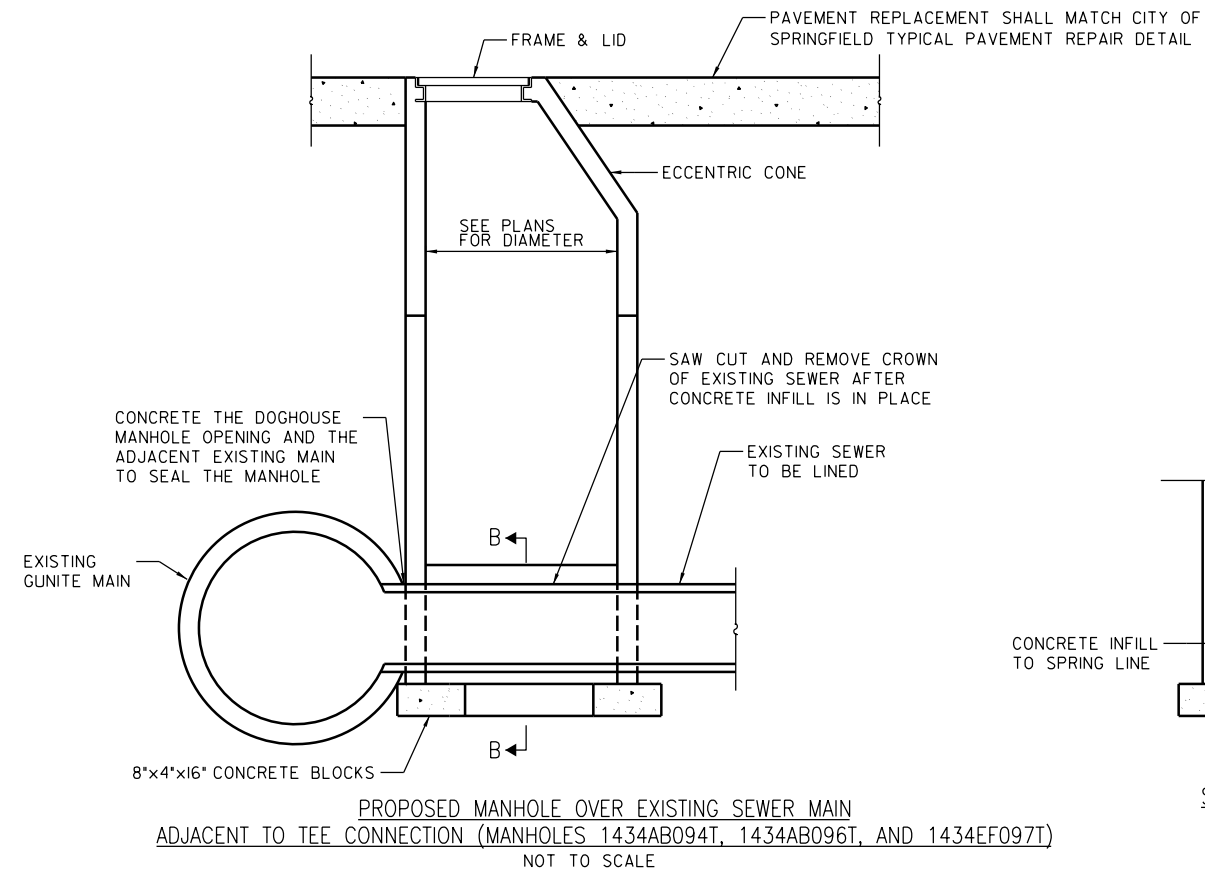
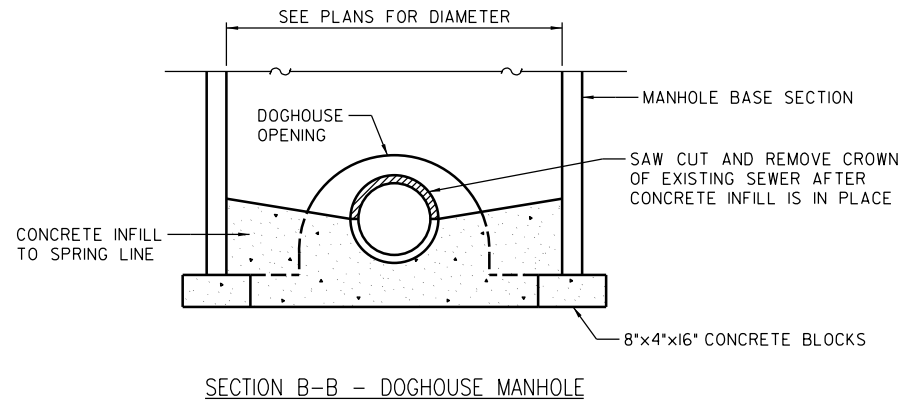
DOGHOUSE MANHOLE NOTES:

1. CONTRACTOR SHALL EXCAVATE THE EXISTING SEWER PER THE PLAN DETAILS AND TEMPORARILY SUPPORT THE PIPE.
2. THE BASE MANHOLE SECTION WITH DOGHOUSE CUTOUTS SHALL BE SET OVER THE EXISTING SEWER AND SHALL BE TEMPORARILY SUPPORTED BY SIX 8"x4"x16" BLOCKS.

5. THE REMAINING SECTIONS OF THE MANHOLE CAN THEN BE INSTALLED.
6. THE RIM AND INVERT ELEVATIONS FOR THE SANITARY SEWERS SHALL BE VERIFIED IN THE FIELD PRIOR TO THE ORDERING OF DOGHOUSE MANHOLE STRUCTURES.

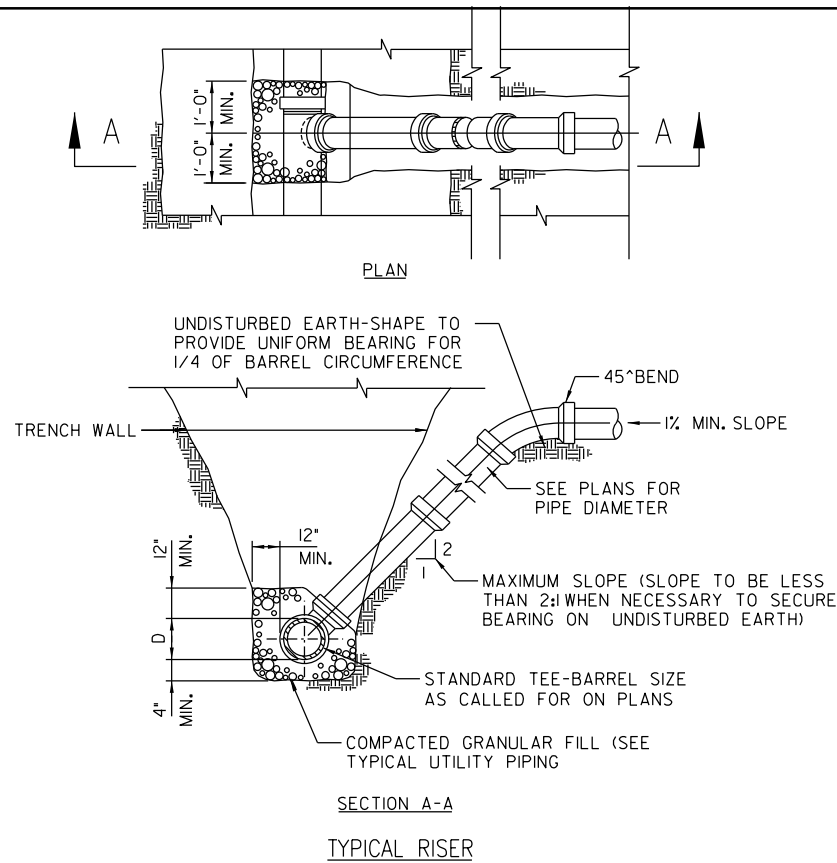
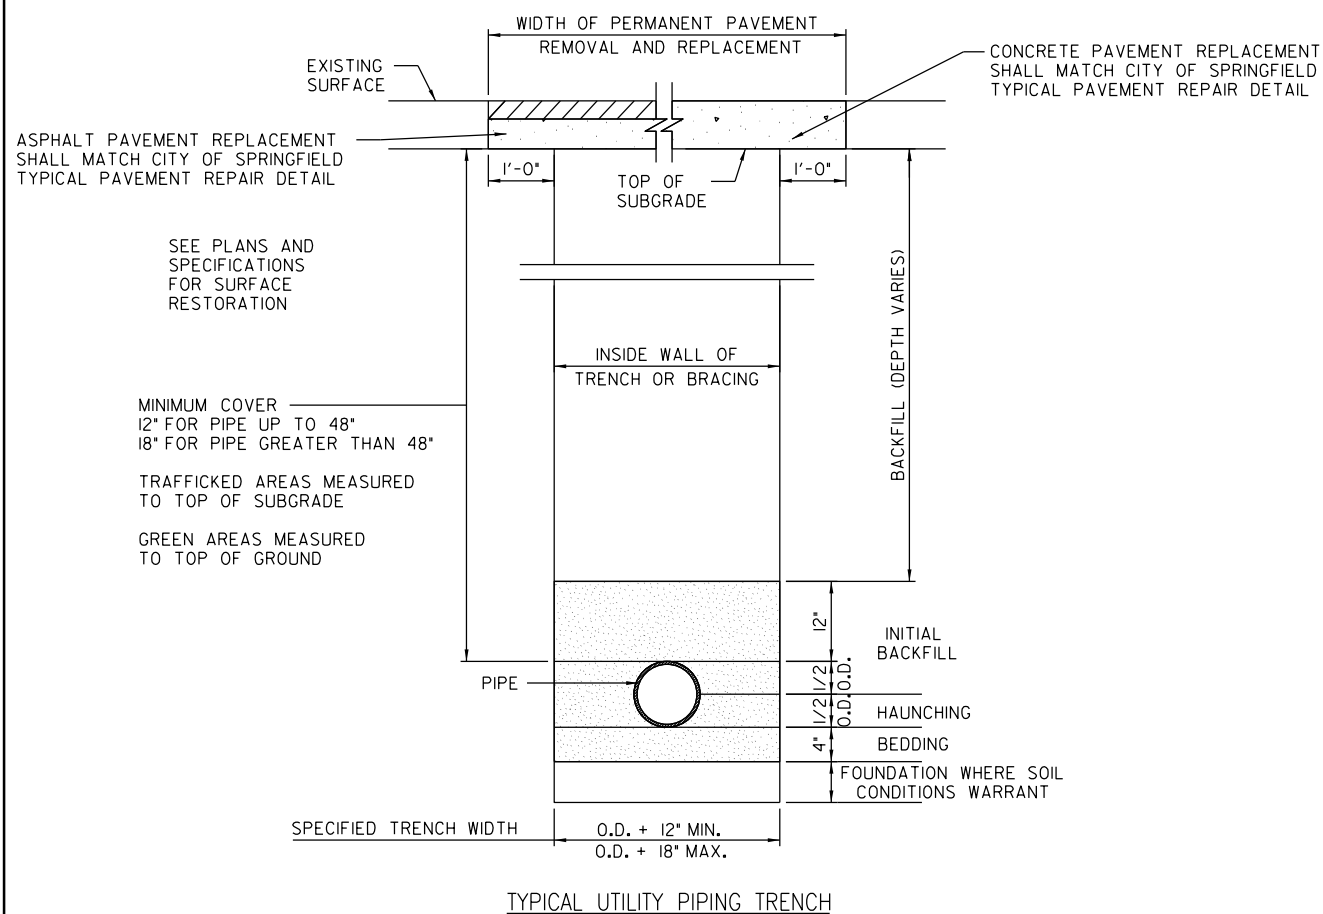
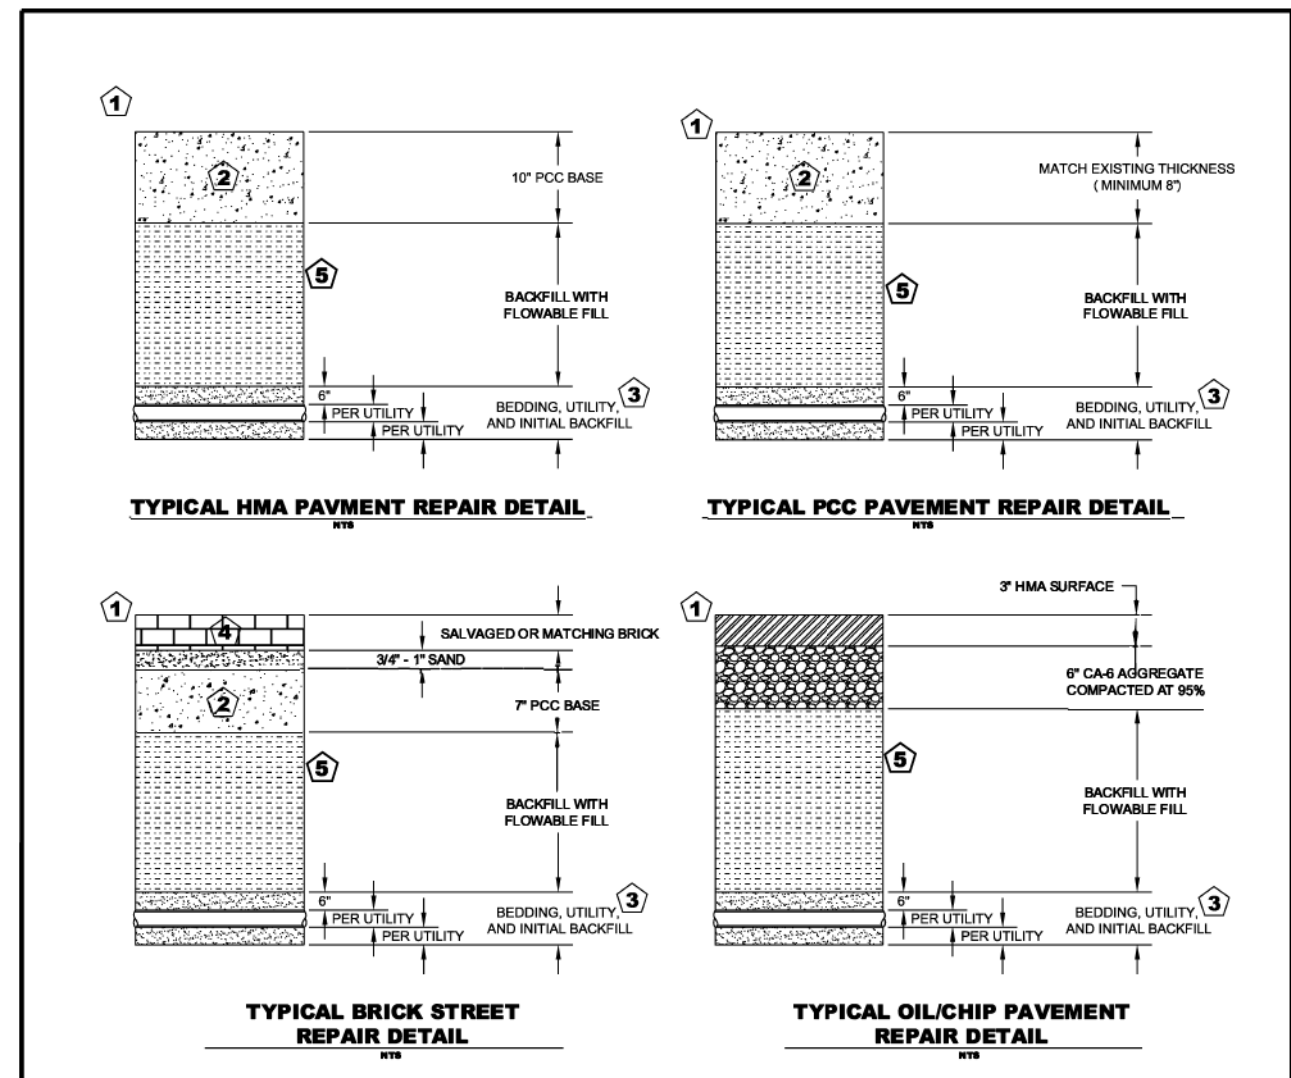
- KEYED NOTES**
- 1 SAWCUT ALL SIDES OF EXISTING PAVEMENT PRIOR TO REMOVAL. FACES SHALL BE SAWCUT AGAIN PRIOR TO REPAIR IF THE EXPOSED FACES ARE DAMAGED.
